Broadcast CAN protocol between KAC-8080I controller and Instrument

1、 Overview

This protocol defines the messages sent from motor controller for instrument via CAN Bus in the automobile net work.

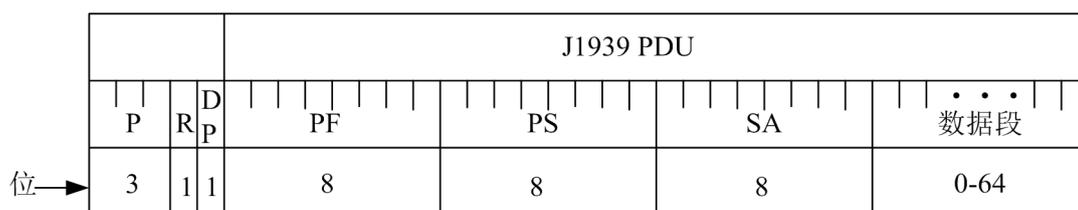
There are two types of PDU format in SAE J1939-21.PDU1 Format(PS=Destination Address) and PDU2 Format(PS =Group Extension). PDU2 is a kind of transfer which doesn't specify a particular target address(The PDU2 Format can communicate CAN Data Frames that are not destination specific.).This protocol uses PDU2 Format.

Definition:P-Priority,R-Reserved,DP-Data page,PF-PDU Format, PS is particular PDU,SA-Source address
